Docket No. 217 – Development and Management Plan Inspection

Northeast Utilities Service Company Certificate of Environmental Compatibility and Public Need for the construction of a 345-kV electric transmission line and reconstruction of an existing 115-kV electric transmission line between Connecticut Light and Power Company's Plumtree Substation in Bethel, through the towns of Redding, Weston, and Wilton, and to the Norwalk Substation in Norwalk, Connecticut.

Date: March 2, 2006

Location: Transition Stations: Hoyts Hill, Archers Lane, Norwalk Junction

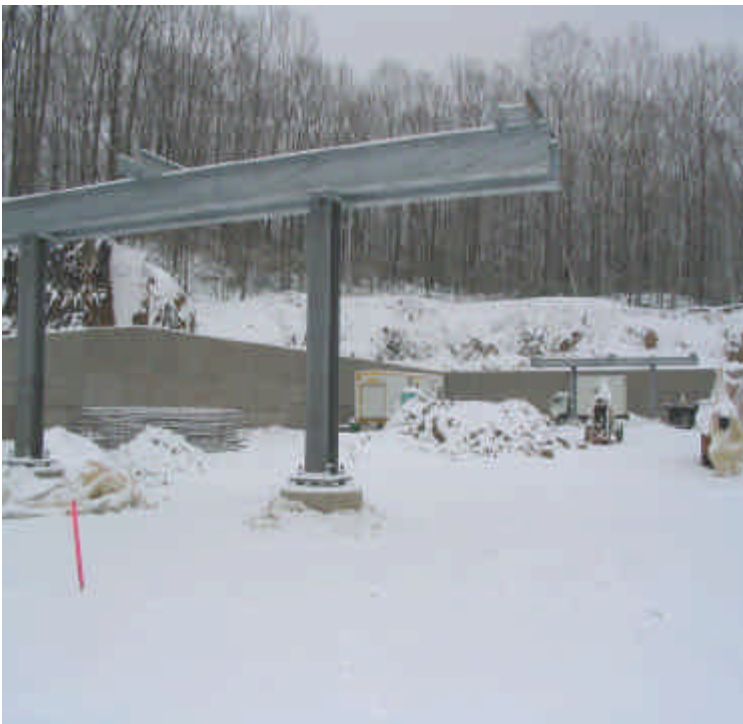
Photo on the left is a view of the station pad with some of the structures in place. Photo on the right shows another view of the pad with 345kV materials in place. 3/2/06.
